Inspection Report

Property Address:
123 Main Street
Houston TX 77007

Date: 7/6/2010	Time:	Report ID: FR-07072010
Property: 123 Main Street Houston TX 77007	Customer: Mr. John Homebuyer	Real Estate Professional:

I. STRUCTURAL SYSTEMS

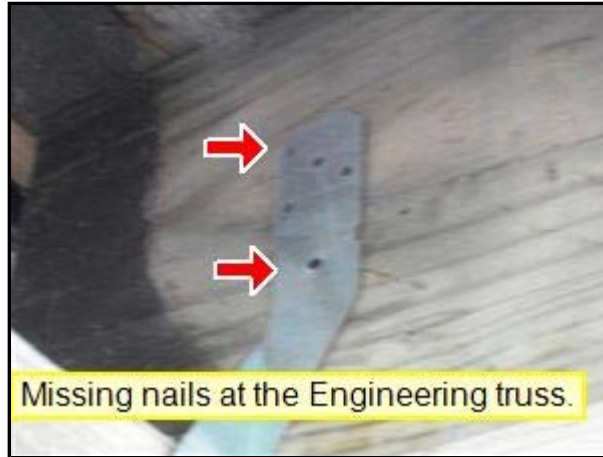
A. Picture 1

(3) Several engineering brackets are not properly installed throughout the floor joist and girder interface. They are either not completely engaged, missing or broken. These bracket should be replaced to ensure an even distribution of the load during windstorm conditions.

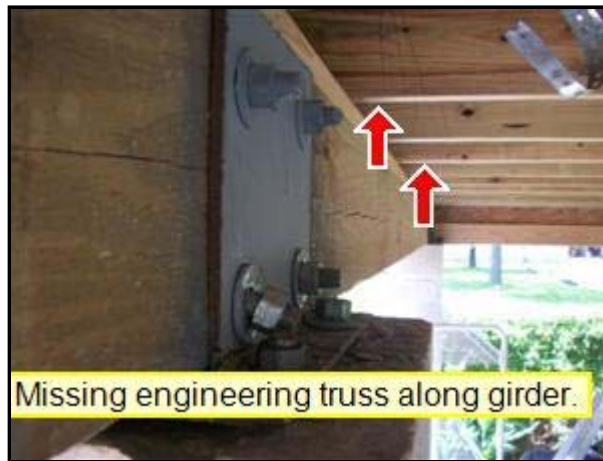
A. Picture 5

(4) There is no bracket at the rear piers. Also, the girder is not properly bolted into the pier. These bracket should be installed as per the engineered per design to ensure an even distribution of the load during windstorm conditions.

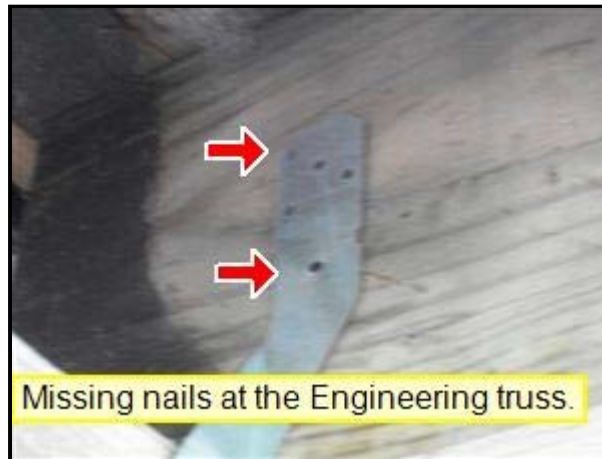
A. Picture 1

(3) Several engineering brackets are not properly installed throughout the floor joist and girder interface. They are either not completely engaged, missing or broken. These bracket should be replaced to ensure an even distribution of the load during windstorm conditions.
