Inspection Report

Property Address:
123 Main Street
Houston TX 77007

EDP Consulting Engineers, PLLC

Date: 12/2/2009	Time: 11:45 AM	Report ID: I-112809
Property: 123 Main Street Houston TX 77007	Customer: Mr. John Homebuyer	Real Estate Professional:

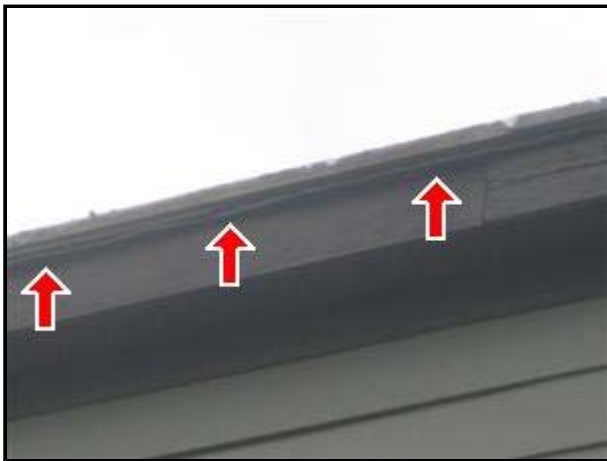
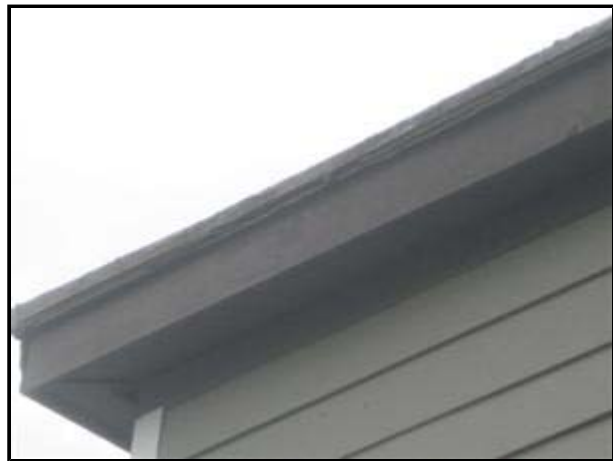
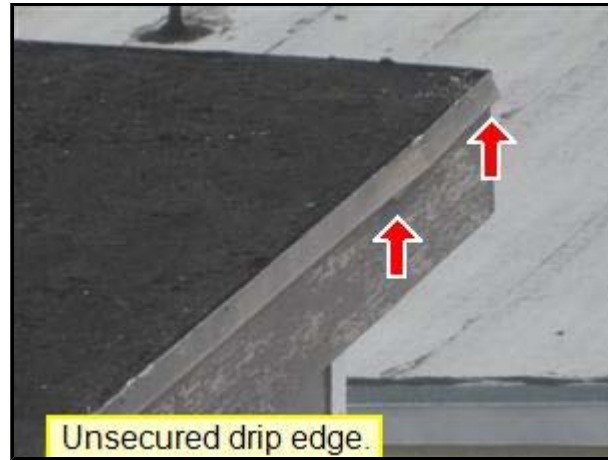
(2) The metal drip edge is loose and deteriorated in various areas along the perimeter of the roof covering. Also, several areas of drip edge have lifted nails. This current condition of the drip edge could cause moisture or water to be blown into the attic when raining and further deterioration may occur if not corrected. A qualified contractor should inspect and repair as needed.

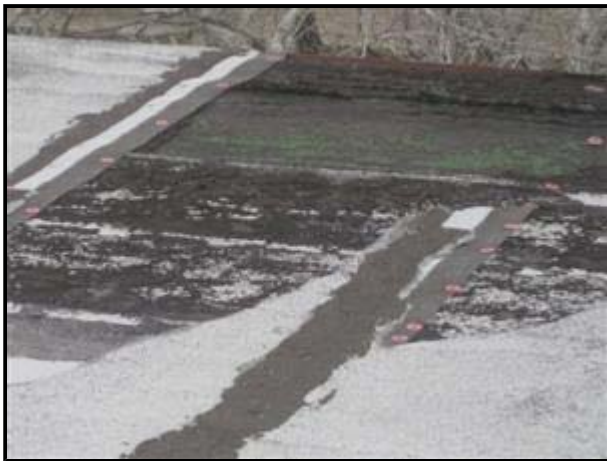
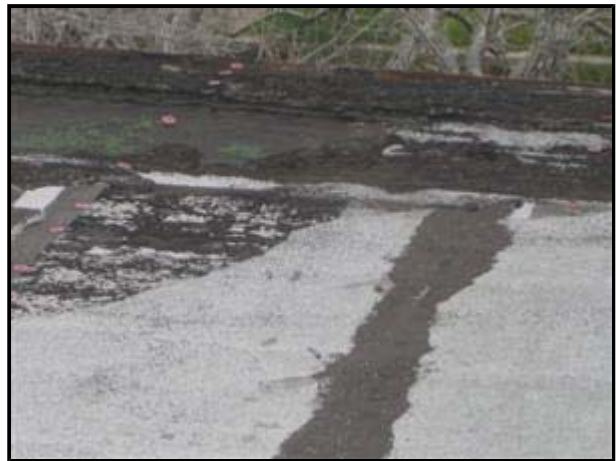
(3) The flat roof covering is damaged at the front of the residence. The decking is exposed and the underlayment is deteriorated. Three or more layers of roof covering exist on roof. This roof has more layers of roof covering than what is normally allowed and can cause excessive weight on roof covering.

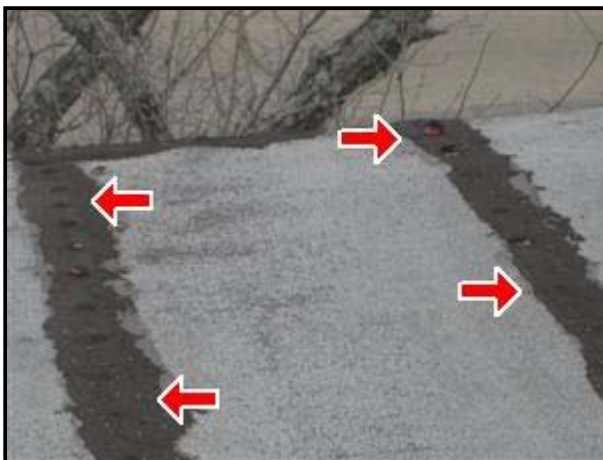
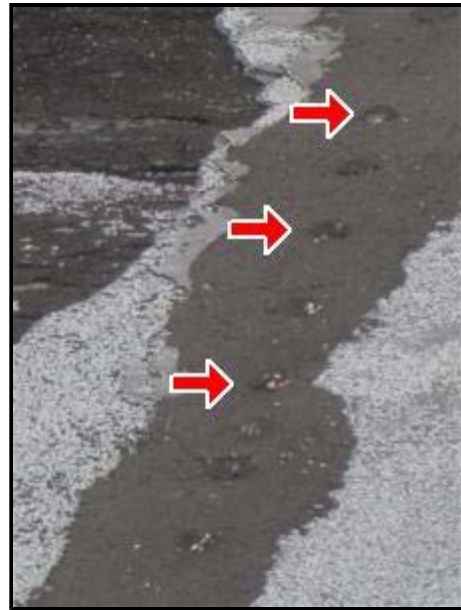
(4) The fastening nails along the overlapped sections of the rolled roofing are protruding at various areas along the roof covering. These should be properly caulked to prevent water intrusion throughout the attic structure.

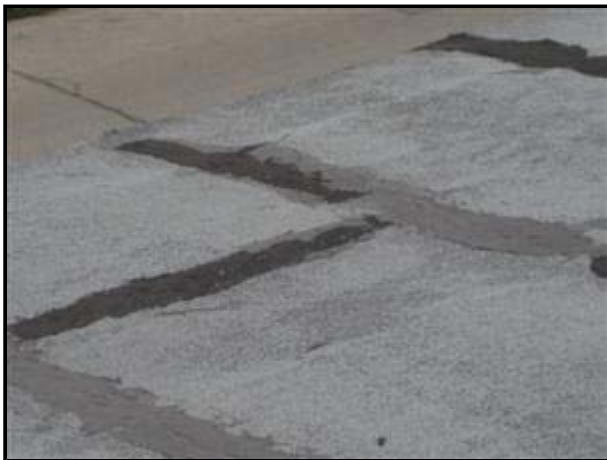
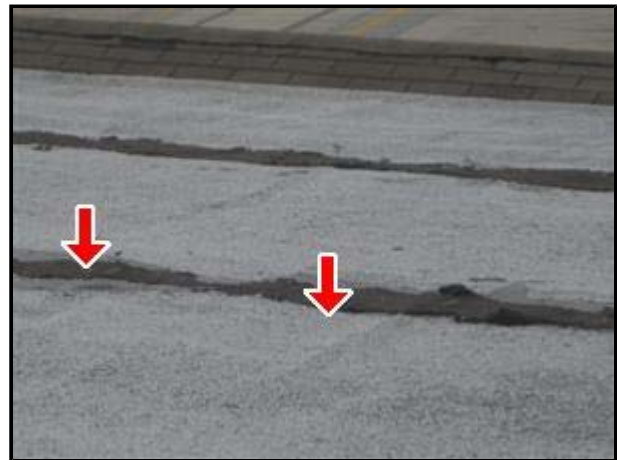
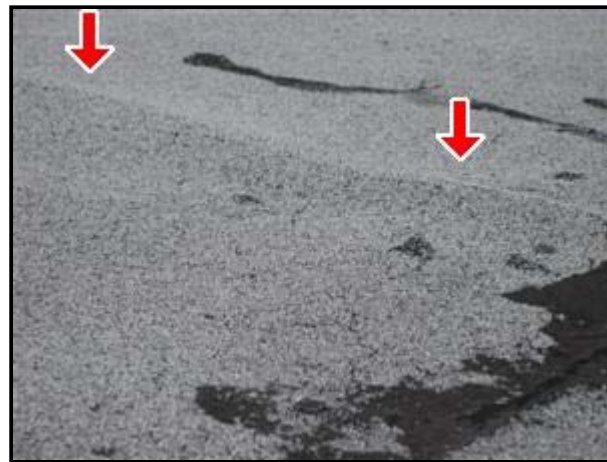
(5) Blistering of the roll roofing sections in various areas of entire roof.

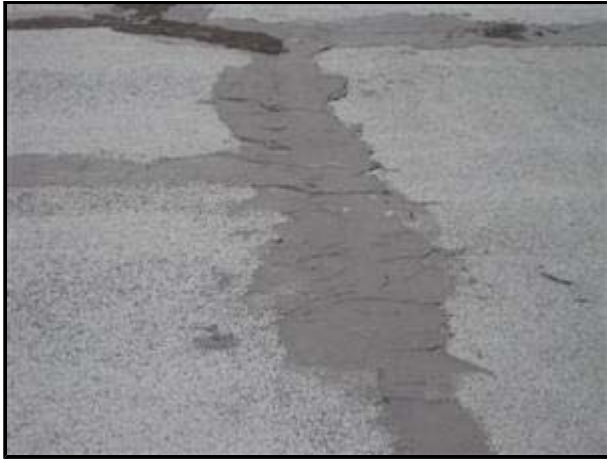
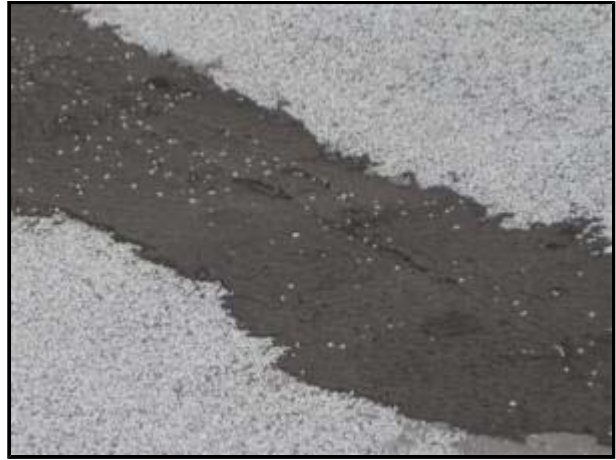
(6) The caulked areas of the overlapped rolled roofing indicates deterioration that may cause possible leakage at the overlapped sections.

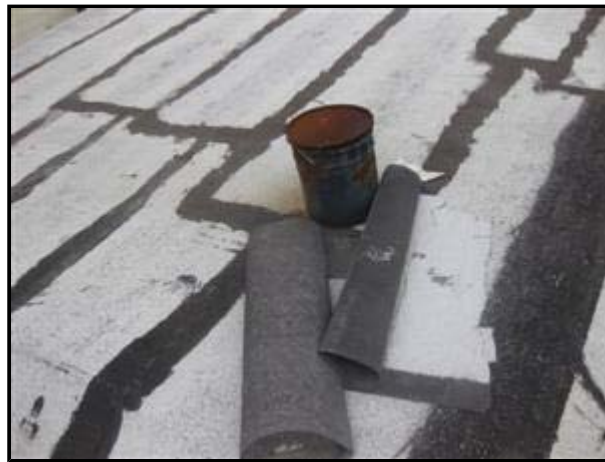
C. Picture 13

(7) Debris has been left of the roof covering. This is a safety issue. Recommend removal of debris.

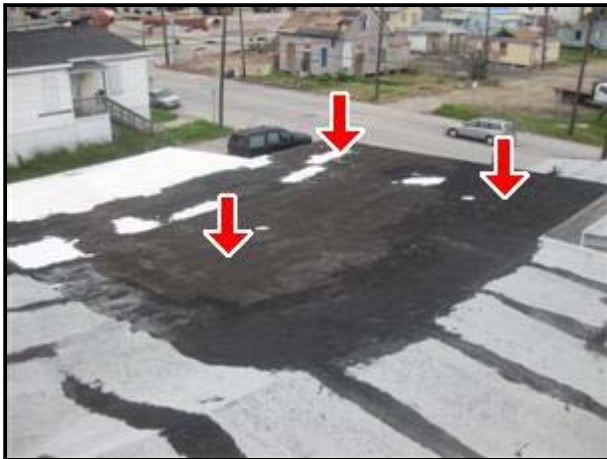
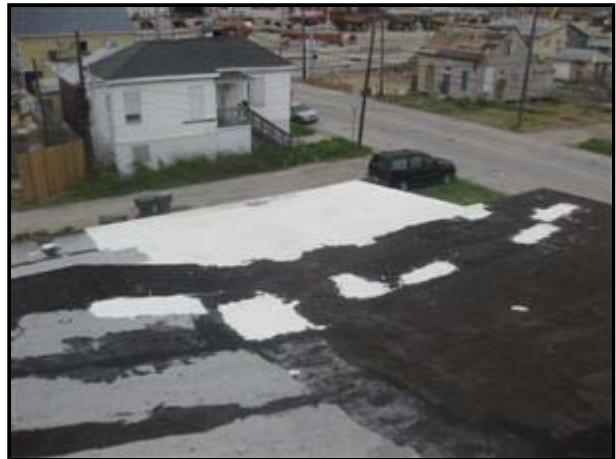
(8) Excessive caulk along the repaired sections of the roof covering.

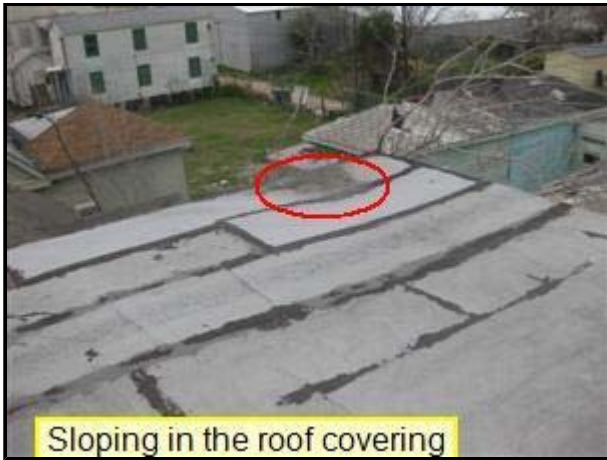
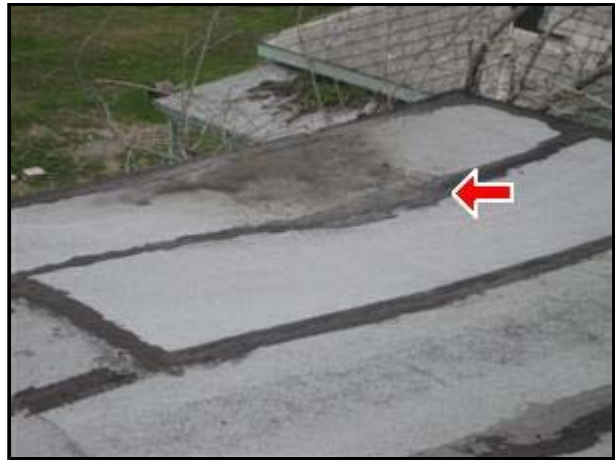
(9) "Cupping" in the roof covering at the rear of the residence. This can cause standing water and lead to possible water penetration to interior of structure.

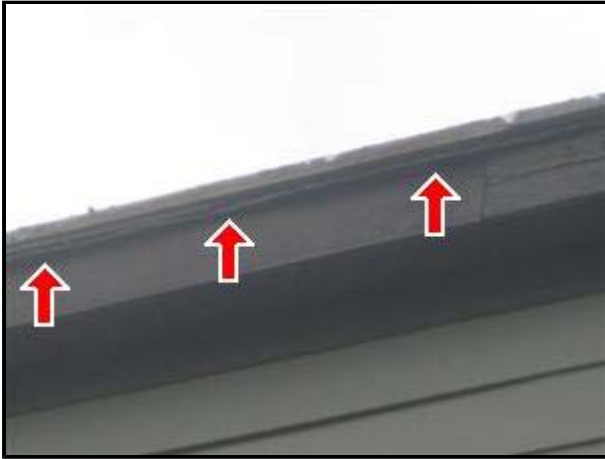
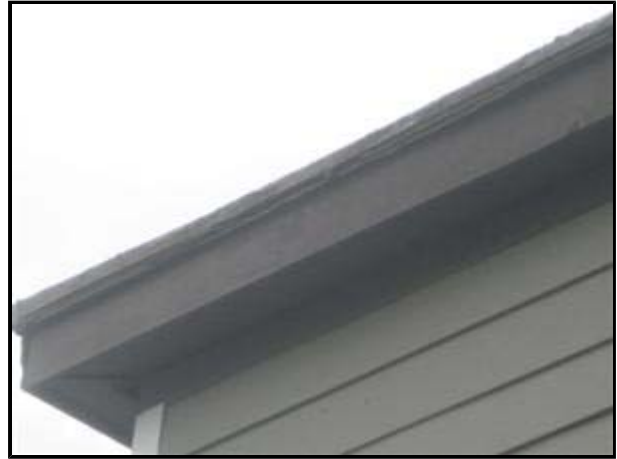
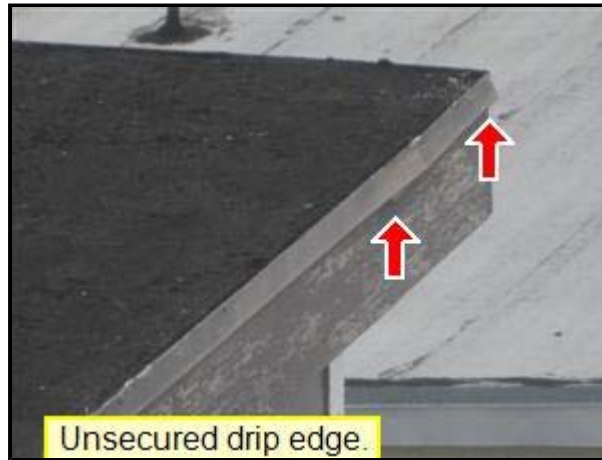
(2) The metal drip edge is loose and deteriorated in various areas along the perimeter of the roof covering. Also, several areas of drip edge have lifted nails. This current condition of the drip edge could cause moisture or water to be blown into the attic when raining and further deterioration may occur if not corrected. A qualified contractor should inspect and repair as needed.

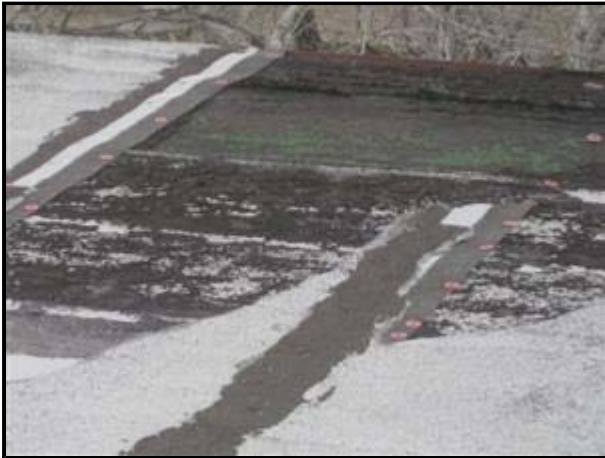
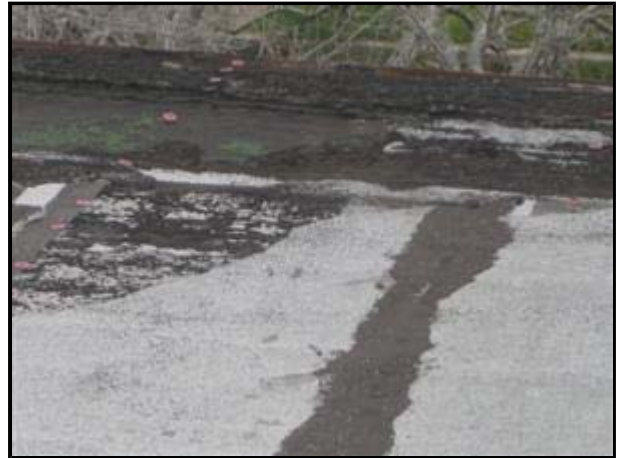
(3) The flat roof covering is damaged at the front of the residence. The decking is exposed and the underlayment is deteriorated. Three or more layers of roof covering exist on roof. This roof has more layers of roof covering than what is normally allowed and can cause excessive weight on roof covering.

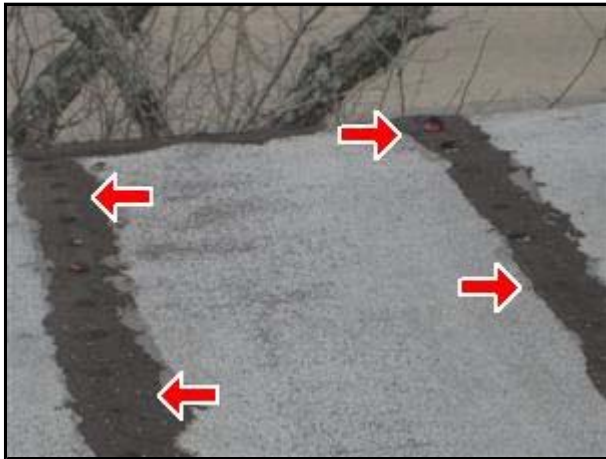
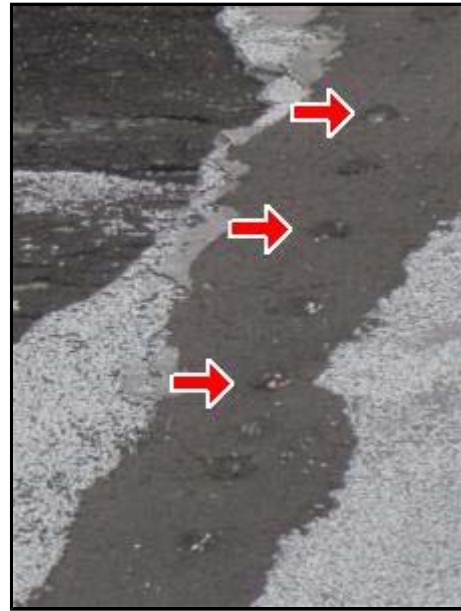
(4) The fastening nails along the overlapped sections of the rolled roofing are protruding at various areas along the roof covering. These should be properly caulked to prevent water intrusion throughout the attic structure.

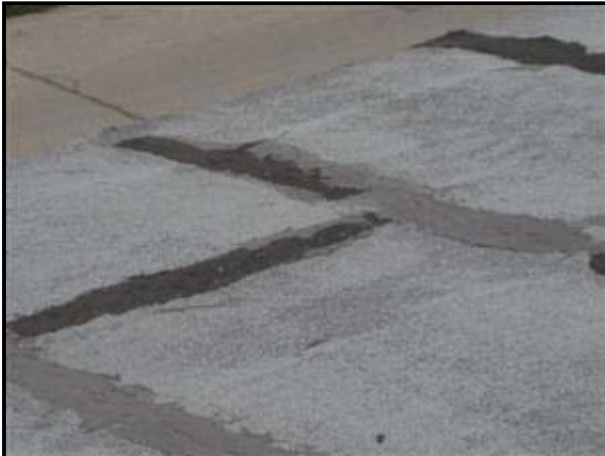
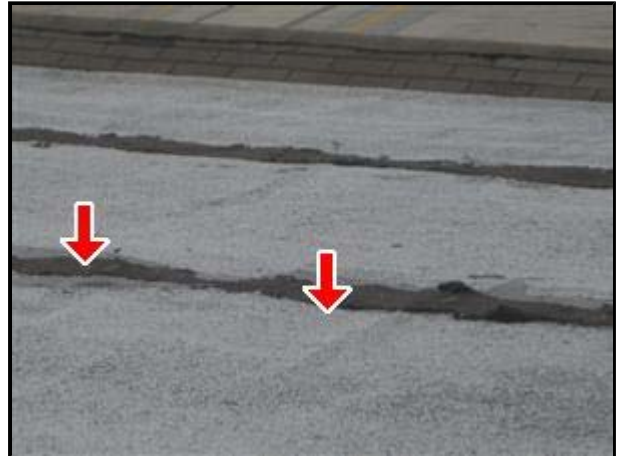
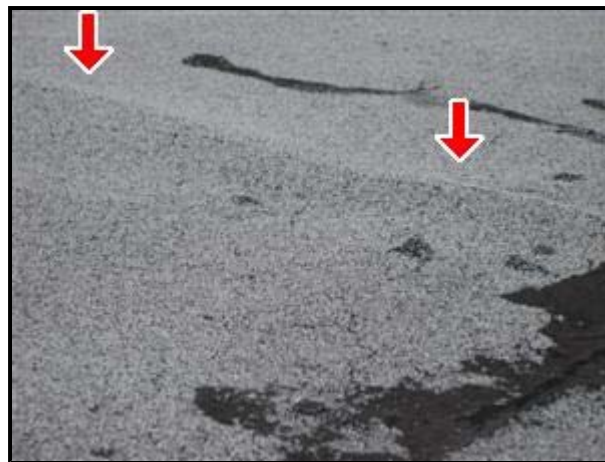
(5) Blistering of the roll roofing sections in various areas of entire roof.

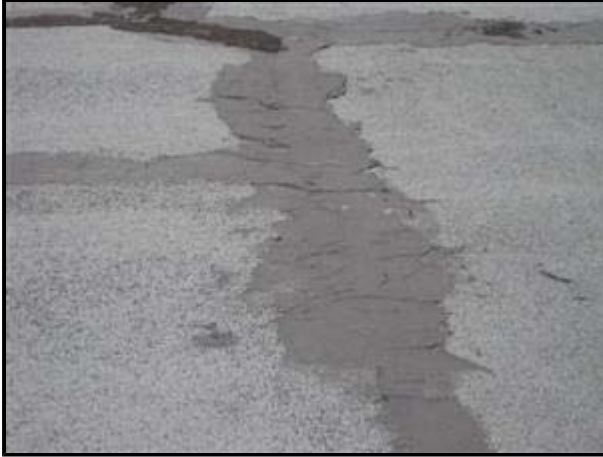
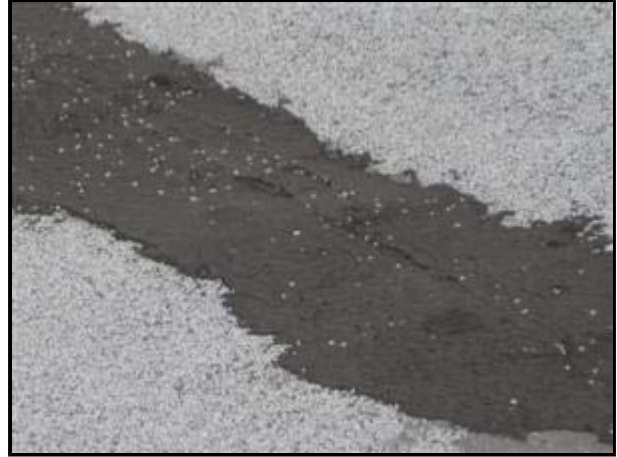
(6) The caulked areas of the overlapped rolled roofing indicates deterioration that may cause possible

leakage at the overlapped sections.

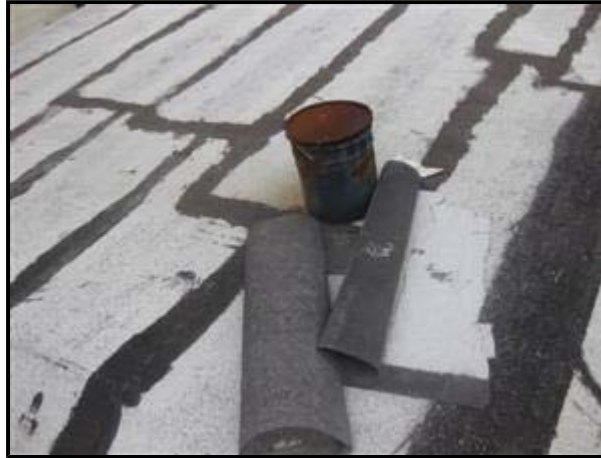
C. Picture 13

(7) Debris has been left of the roof covering. This is a safety issue. Recommend removal of debris.

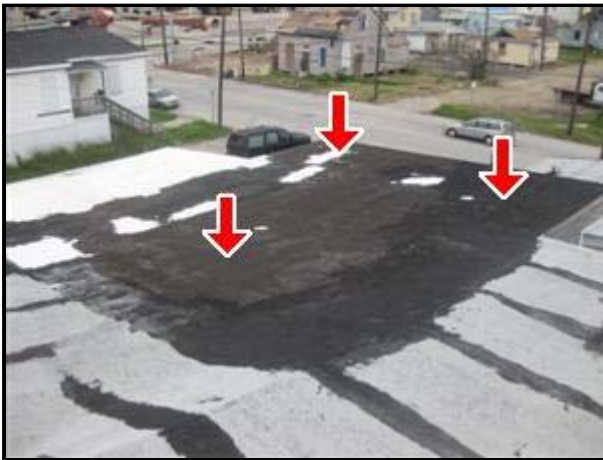
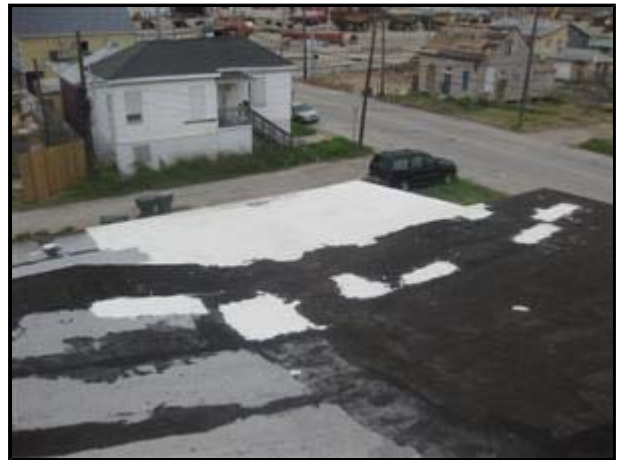
(8) Excessive caulk along the repaired sections of the roof covering.

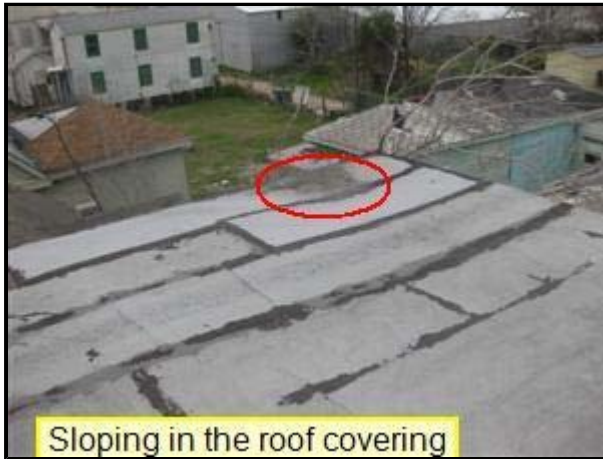
C. Picture 16

(9) "Cupping" in the roof covering at the rear of the residence. This can cause standing water and lead to possible water penetration to interior of structure.

Sloping in the roof covering
