# Inspection Report

## Jefferson House Apartments

**Property Address:**  
6200 Gufton  
Houston TX 77081

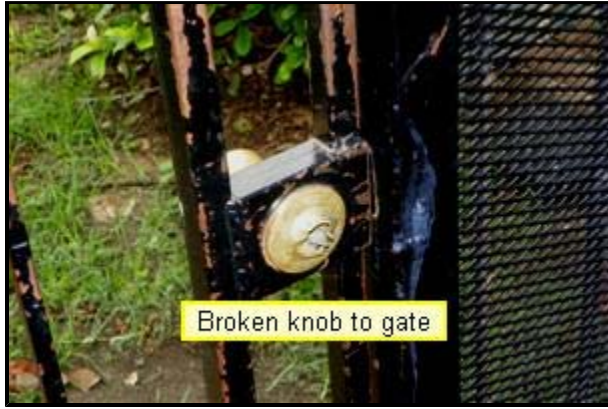
Site entrance to unit

Broken knob to gate

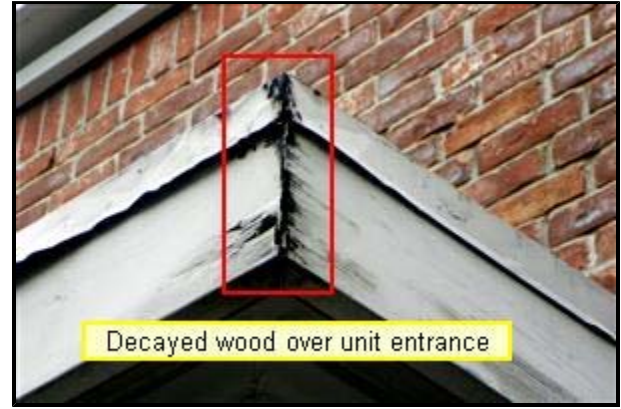
Site over residence entrance

Decayed wood over unit entrance

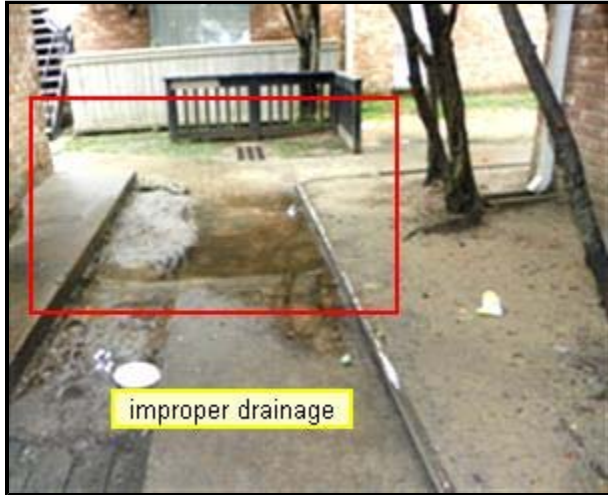
improper drainage

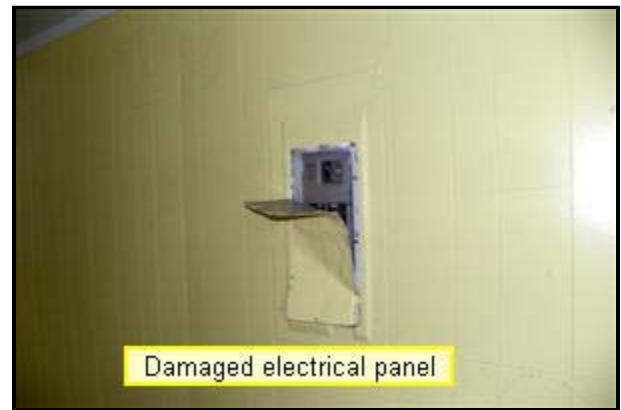
Site laundry room

Damaged electrical panel

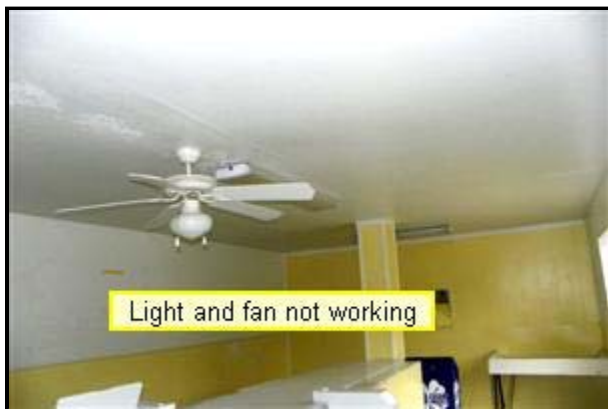
Light and fan not working

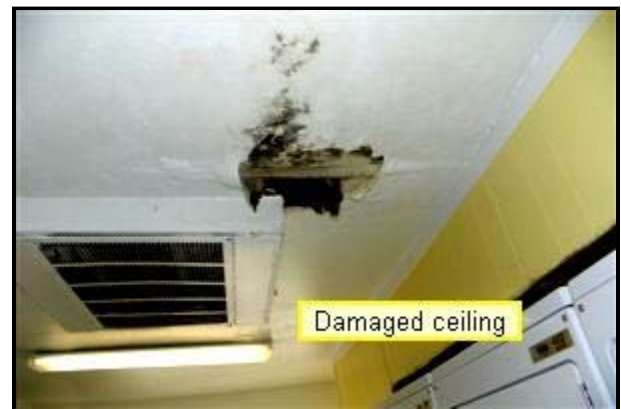
Site laundry room

Damaged ceiling
