Inspection Report

Property Address:
123 Main Street
Houston TX 77007

Date: 7/6/2010	Time:	Report ID: FR-07072010
Property: 123 Main Street Houston TX 77007	Customer: Mr. John Homebuyer	Real Estate Professional:

I. STRUCTURAL SYSTEMS

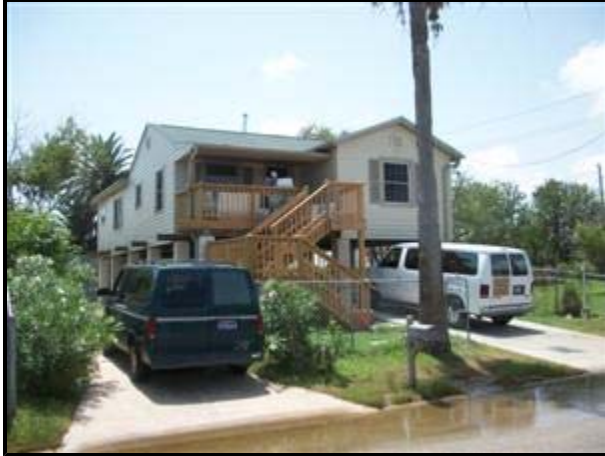
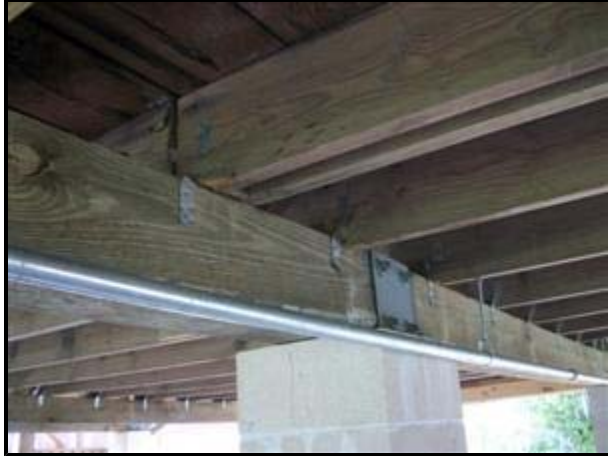
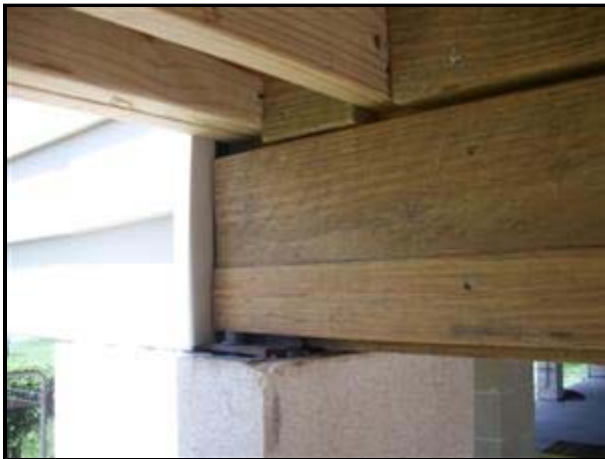
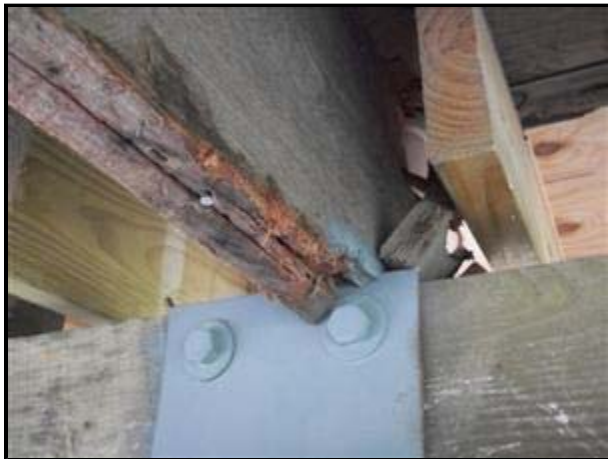
Note: Based on the numerous defects and poor workmanship, it is the inspectors opinion that a sampling of piers need an internal inspection due to the lack of inspection during construction.

(1) The pier pile placement was not the same as the provided **Engineered foundation Layout**. More than 35% of the piers were not visible on the layout or not in the same location. Foundation Repair company must provide an updated layout before a Windstorm certificate can be issued.
